FIELD AND LABORATORY AGING OF POLYMERIC DISTRIBUTION CABLE TERMINATIONS: PART 1-FIELD AGING

R. S. Gorur, Senior Member
Department of Electrical Engineering
Arizona State University
Tempe, AZ 85287

B. S. Bernstein, Fellow
Electric Power Research Institute
Washington D. C.
20036

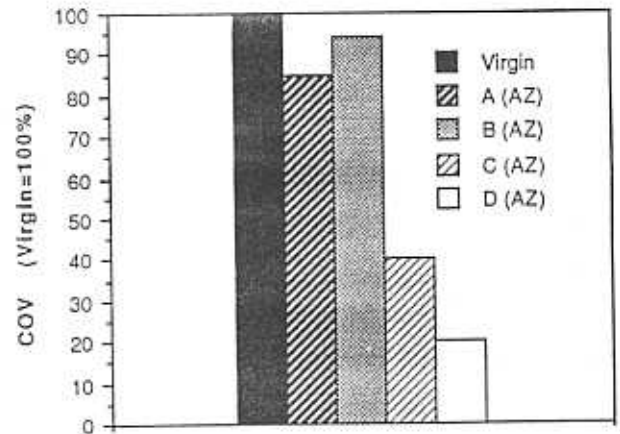
Fig. 8: Maximum COV change. COV (eV) for virgin (100%) are A=900, B=1000, C=800, D=600.

It can be seen that the complete loss in hydrophobicity of termination C and D, partial loss of hydrophobicity of termination A, almost unchanged hydrophobicity of termination B are clearly borne out by the Cross Over Voltage measurement. Interestingly, the maximum changes occurred in the Arizona site, demonstrating the dominant role of UV on surface wettability.
