FIELD AND LABORATORY AGING OF POLYMERIC DISTRIBUTION CABLE TERMINATIONS: PART 1-FIELD AGING

R. S. Gorur, Senior Member
Department of Electrical Engineering
Arizona State University
Tempe, AZ 85287

B. S. Bernstein, Fellow
Electric Power Research Institute
Washington D. C.
20036

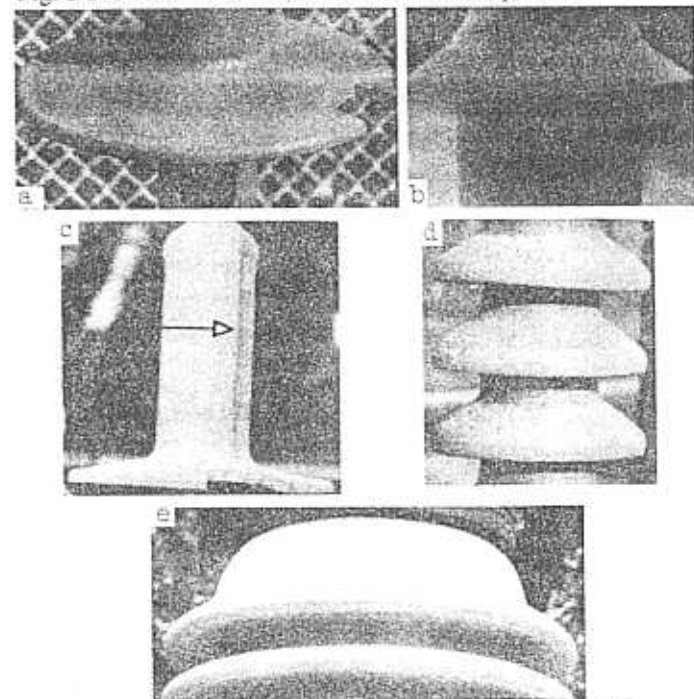
1. There were no failures, or any apparent degradation serious enough to suggest failure.
2. The surface of all the new polymer terminations was hydrophobic. Field exposure caused changes in the wetting pattern. For EPR termination C and D, the surface was completely wettable in periods ranging from 9-12 months and 1-3 months of field exposure, respectively. The hydrophobicity of Terminations B (including the previously field exposed samples) was virtually unchanged from the new condition. The hydrophobicity of Termination A was better than Termination C but not as good as B.

3. Chalking and crazing from UV exposure was apparent only on EPR termination D and was noticeable within 6 months of exposure in all sites. In addition, Termination D in the Arizona site had minor erosion (not serious enough to cause alarm) on the shank.

5. Mold growth in the form of black spots were observed on the silicone rubber termination B in Georgia and Texas, both regions being characterized by high relative humidity (RH) and average daily temperatures (subtropical environment). It is interesting to note that in the Arizona site with high temperature but low RH, and in the Maine Site with high RH, but low temperature, there were no mold growth. The mold growth was sporadic and did not affect either the leakage current or the integrity of the terminations.

Fig. 5: (a) Partly wettable-Term. A; (b) Mold growth-Term. B; (c) Hardware weathering stain-Term. C; (d) Chalking, crazing-Term. D; (e) Relatively clean surface-Term. E.

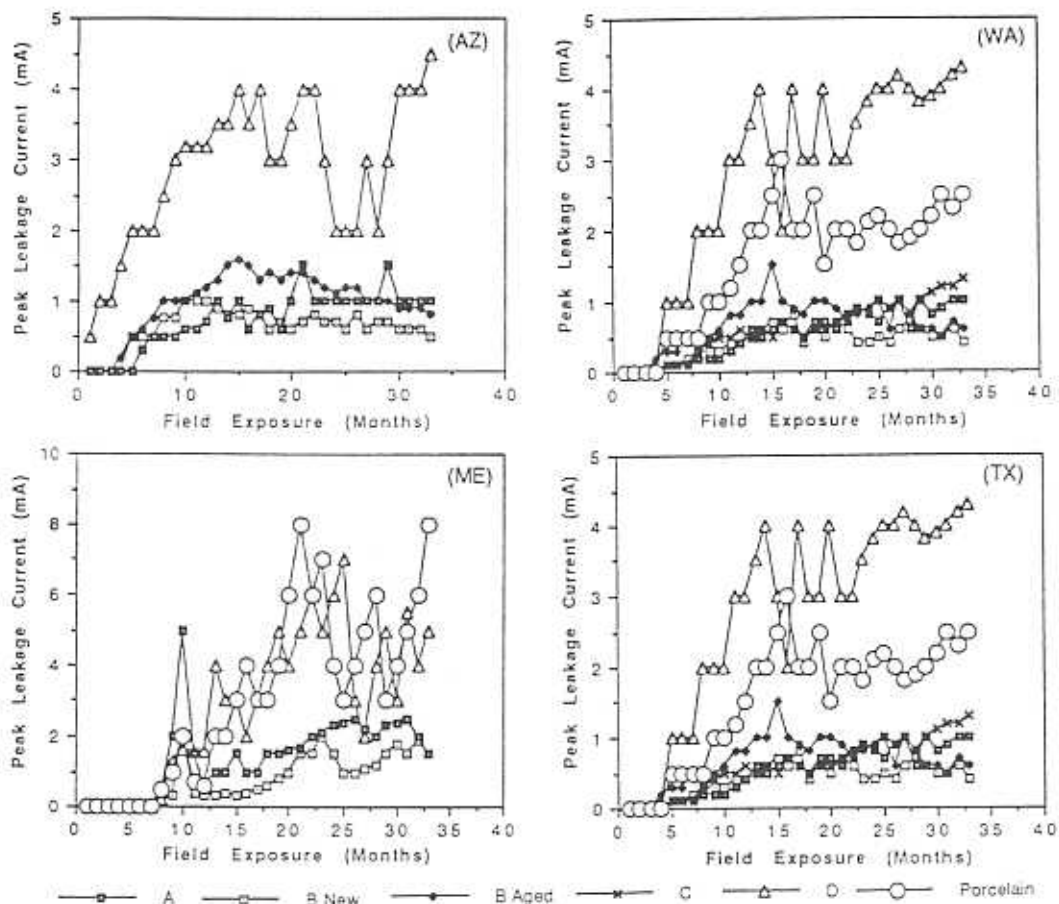
Fig. 6: Highest Peak Leakage Current by Month

The highest peak leakage current recorded every month in four of the testing sites is shown in Fig. 6. Table 4 lists the typical leakage current pulse data from one site. There was a large volume of data from which the following important observations have been made:

3. Most of the leakage current activity was recorded during night and early morning hours, indicating condensation wetting by dew and fog.
4. Initially, the leakage current was low (< 1 mA) and increased subsequently for all samples. On porcelain and EPR D terminations, 5-10 mA range pulses were recorded. Consistently, the lowest peaks occurred on Termination A and B, and high peaks on Termination D and porcelain. Termination C's leakage current was within this range. It is interesting to note that Termination D, despite the higher leakage distance than C, had higher current. This is attributed to differences in the material formulation.

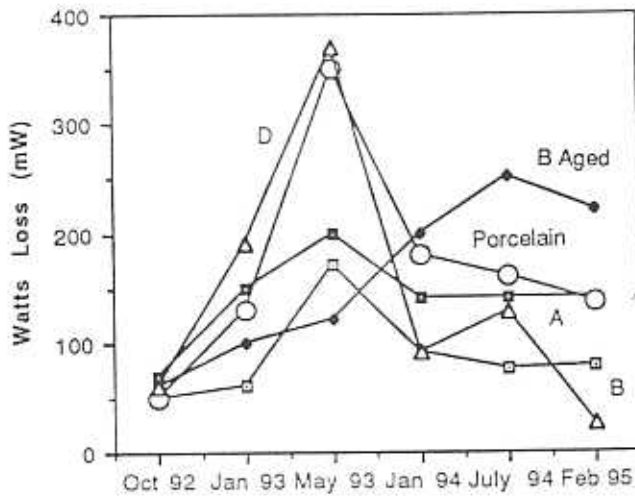
5. The Watt loss from the Georgia site, shown in Fig. 7, illustrates similar trends as leakage current from other sites. EPR D and porcelain terminations have higher watt loss than terminations A and B. However, even the highest watt loss is negligible.

Fig. 7: Watt Loss Data from Georgia Site.

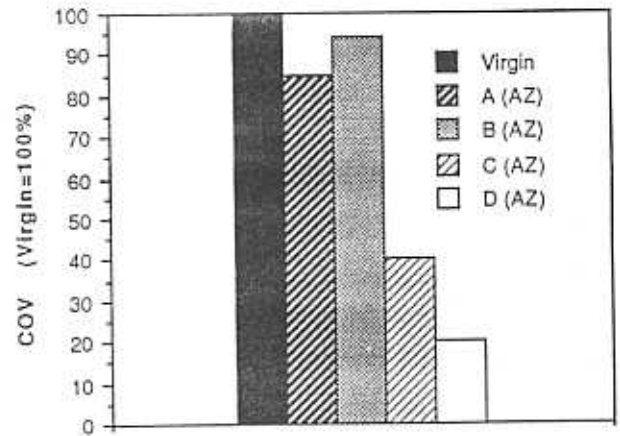
Fig. 8: Maximum COV change. COV (eV) for virgin (100%) are A=900, B=1000, C=800, D=600.

It can be seen that the complete loss in hydrophobicity of termination C and D, partial loss of hydrophobicity of termination A, almost unchanged hydrophobicity of termination B are clearly borne out by the Cross Over Voltage measurement. Interestingly, the maximum changes occurred in the Arizona site, demonstrating the dominant role of UV on surface wettability.

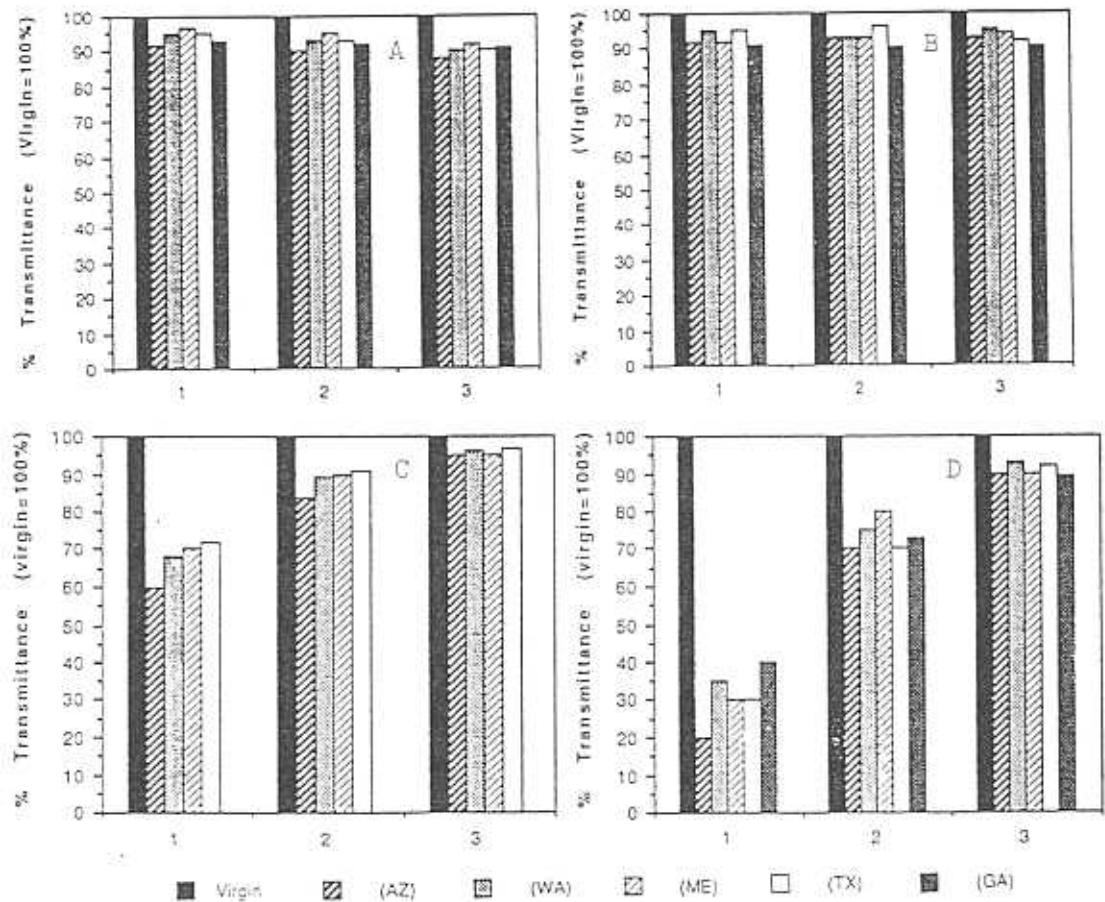
Fig. 9: IR data on Terminations before and after 3 year field exposure. Information on Groups on X-axis is shown in Table 5.

Fig. 9 shows the relative transmittance peaks corresponding to chemical groups in the polymer side chain and backbone. The magnitude of the peaks for the virgin samples is normalized to 100%. All these peaks decreased with field exposure. For all polymers, the decrease for the side chain group was more noticeable than the backbone. In fact, the change in the backbone peak was negligible for all samples,

indicating that the integrity of the material after field exposure is still unchanged from the virgin condition. Decrease in the transmittance peaks of side chain, reflecting wettability changes, were more noticeable for terminations C and D, being higher for D. For terminations A and B, even the superficial changes are minimal, being least for Termination B.
