FIELD AND LABORATORY AGING OF POLYMERIC DISTRIBUTION CABLE TERMINATIONS: PART 1-FIELD AGING

R. S. Gorur, Senior Member
Department of Electrical Engineering
Arizona State University
Tempe, AZ 85287

B. S. Bernstein, Fellow
Electric Power Research Institute
Washington D. C.
20036

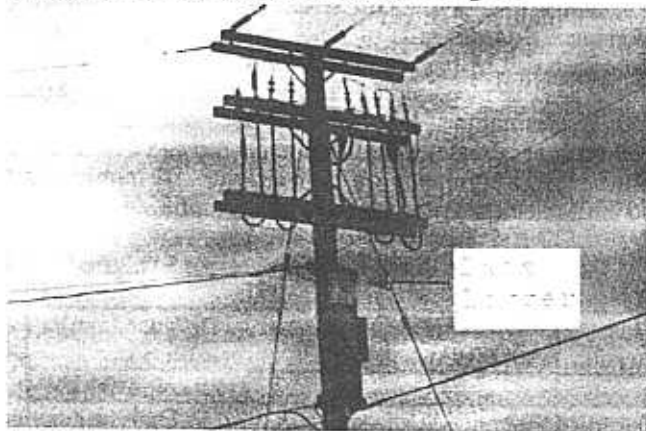
Fig. 3: Typical Arrangement in a Test Site

neutral distribution cable bent to a U shape. Both ends of each cable section had the same termination type. A schematic of the test arrangement is shown in Fig. 2. In order to facilitate leakage current monitoring of individual terminations, the ground strap was separated from the concentric neutral and grounded via a precision resistor. A photograph of one test site is shown in Fig. 3.
